SUMMARY
 1234 Main St Fayetteville, Fayetteville,
 NC 28348
 John Freudenberg
 October 29, 2023

John Freudenberg
 Certified Master Inspector, Lic. #4202
 Silk Inspections, LLC
 (910) 248-9513
john@silkinspections.com

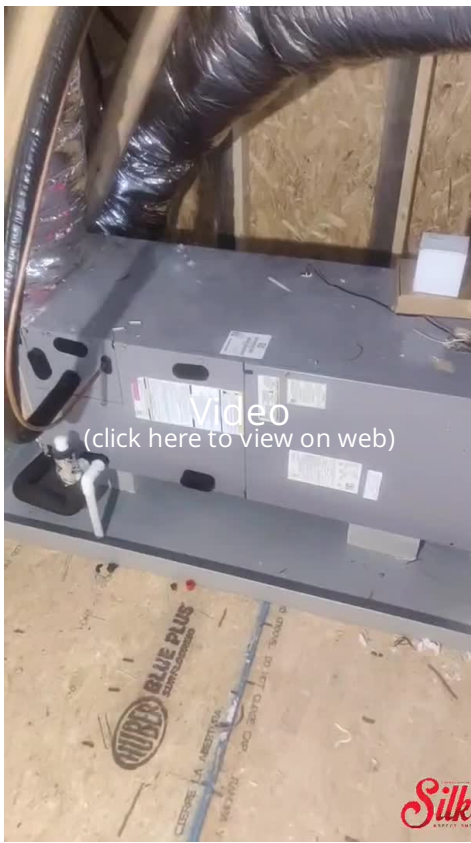
7.1.1 General

**FLOAT SWITCH
 NOT INSTALLED**

A float switch was not installed on the condensation drain pan beneath the air handler. A float switch detects the presence of moisture and turns off the unit when it is detected. This condition may cause moisture intrusion in the home in the event the condensation drain pan were to overflow with water and the condensation drain tubes were blocked. Recommendation consult with a qualified HVAC professional to evaluate this condition and perform any necessary repairs.

Recommendation
 Contact a qualified HVAC professional.

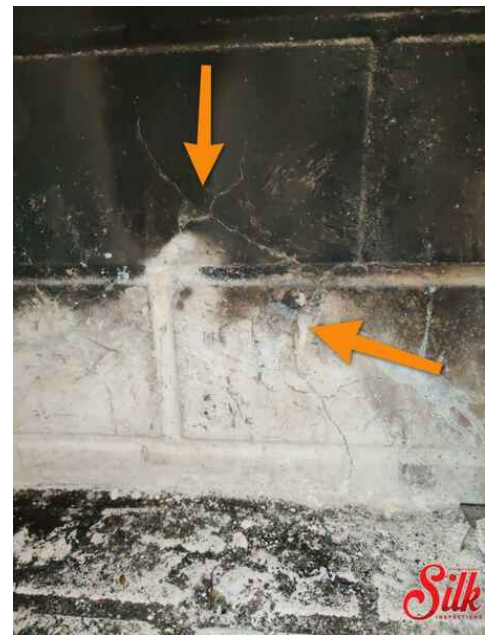
7.7.1 Fireplace/Chimney **CRACKED FIREBOX**

Deficiencies, Safety Concerns

There were cracks observed in the firebox. This condition is a safety/fire concern. Recommendation: consult with a qualified fireplace contractor to evaluate this condition and perform any necessary repairs prior to operating the fireplace.

Recommendation
Contact a qualified fireplace contractor.

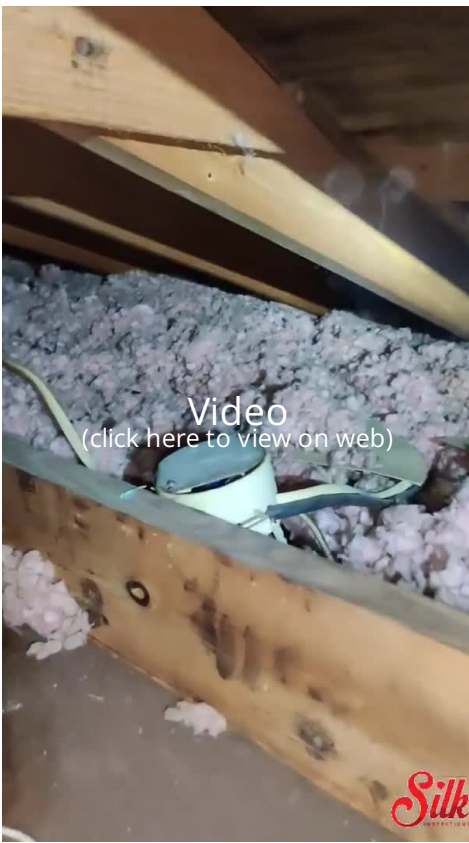
8.2.1 Electrical **SMOKE - JUNCTION BOX**

Immediate Action Items, Safety Hazards

Smoke was observed coming from a junction box. This condition is a fire hazard and should be evaluated and corrected immediately by a qualified electrical professional. Recommendation: consult with a qualified electrical professional to evaluate this condition and perform any necessary repairs.

Recommendation
Contact a qualified electrical contractor.

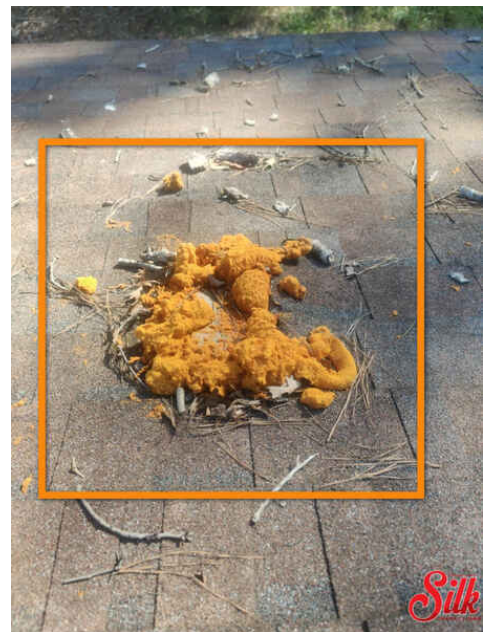
9.2.1 Asphalt Shingle **IMPROPER/INADEQUATE PREVIOUS REPAIRS**

Deficiencies, Safety Concerns

The roof covering had evidence of inadequate repairs. This condition may lead to moisture intrusion and may indicate that the roof covering is at the end of its useful life. Recommendation: consult with a qualified roofing professional to evaluate this condition and perform any necessary repairs or replacement.

Recommendation
Contact a qualified roofing professional.
